U.S. ARMY CORPS OF ENGINEERS - DETROIT DISTRICT

**PROPOSED ADVANCE MEASURES FLOOD CONTROL PROJECT
HAMPTON TOWNSHIP, BAY COUNTY, MICHIGAN
INTENSIVE ARCHAEOLOGICAL SURVEY**

**CONTRACT DACW-35-87-0-0009
DELIVERY ORDER #0001**

**CAMINOS ASSOCIATES
BAY CITY, MICHIGAN**

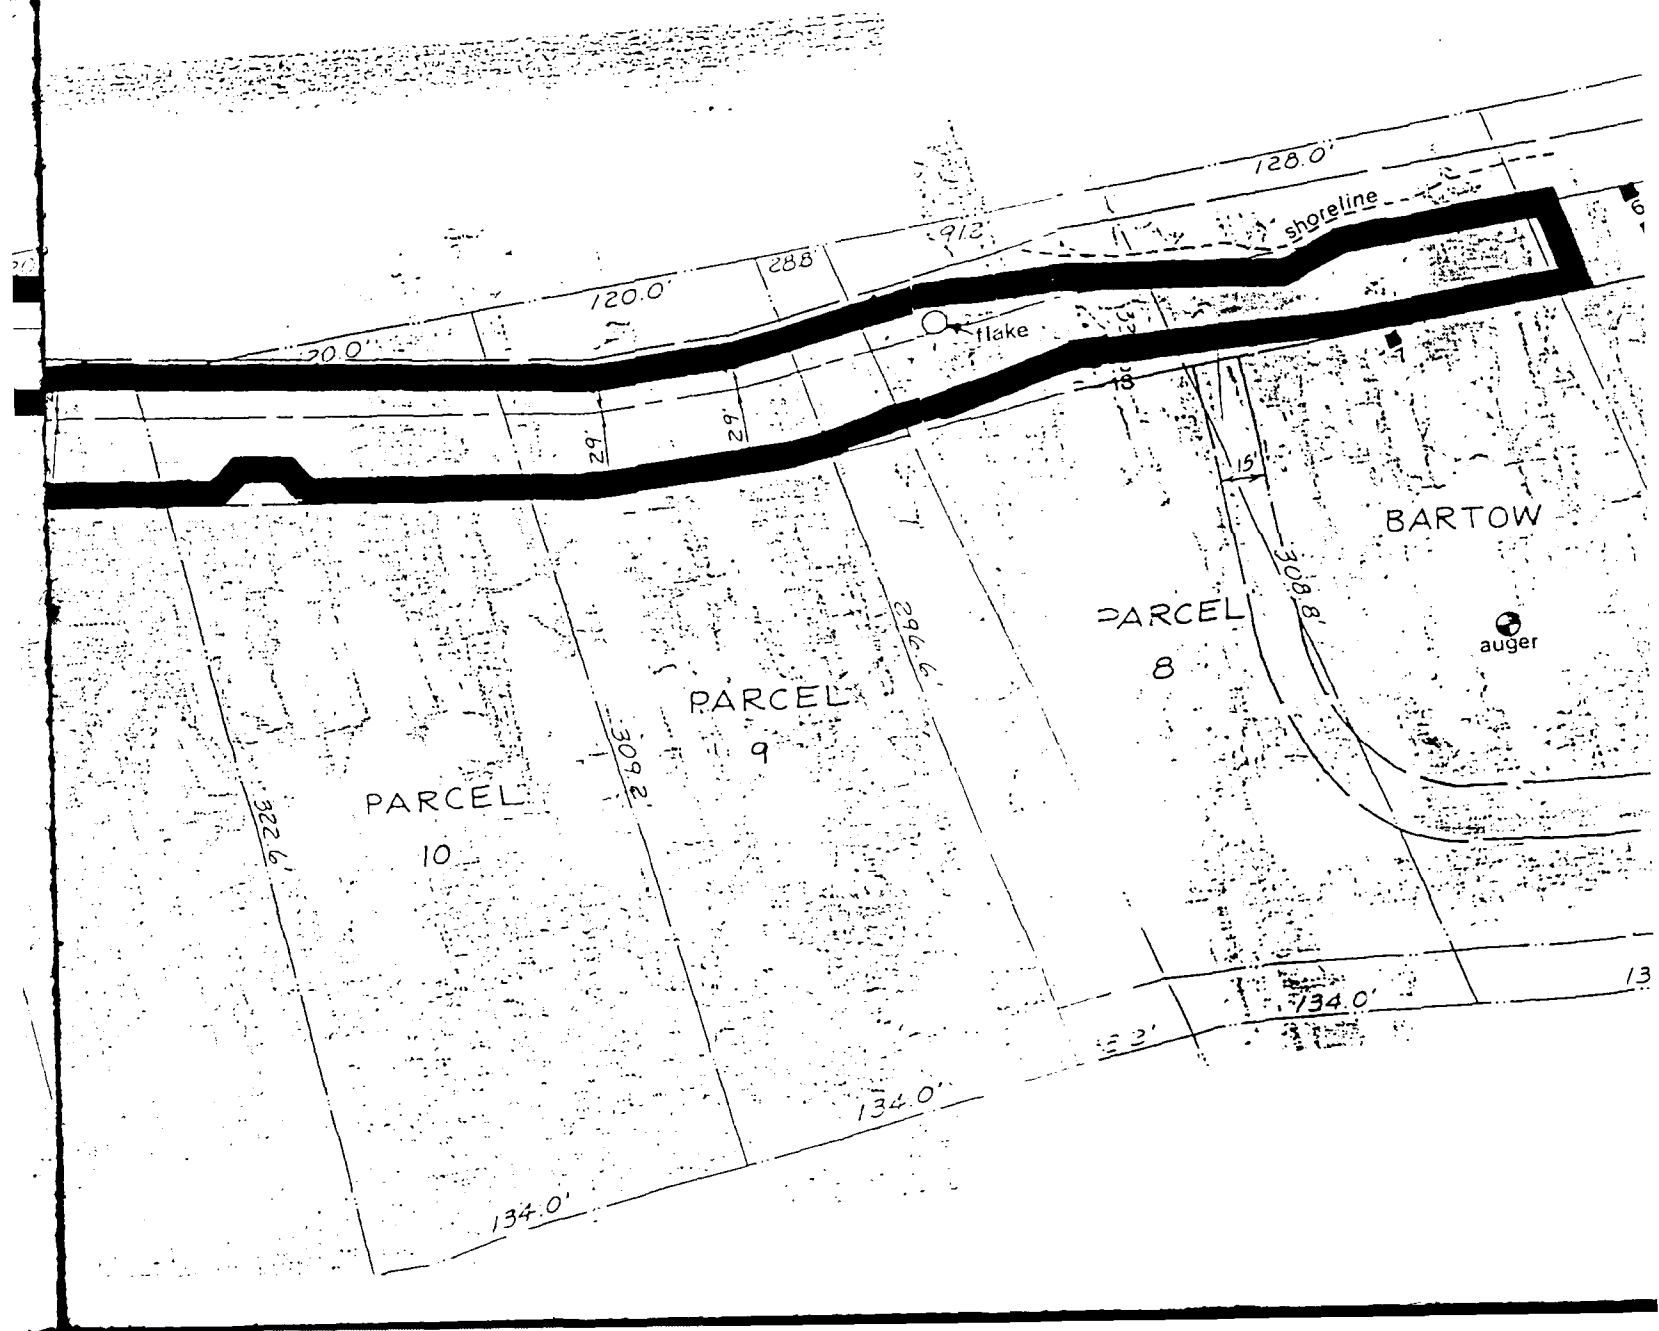
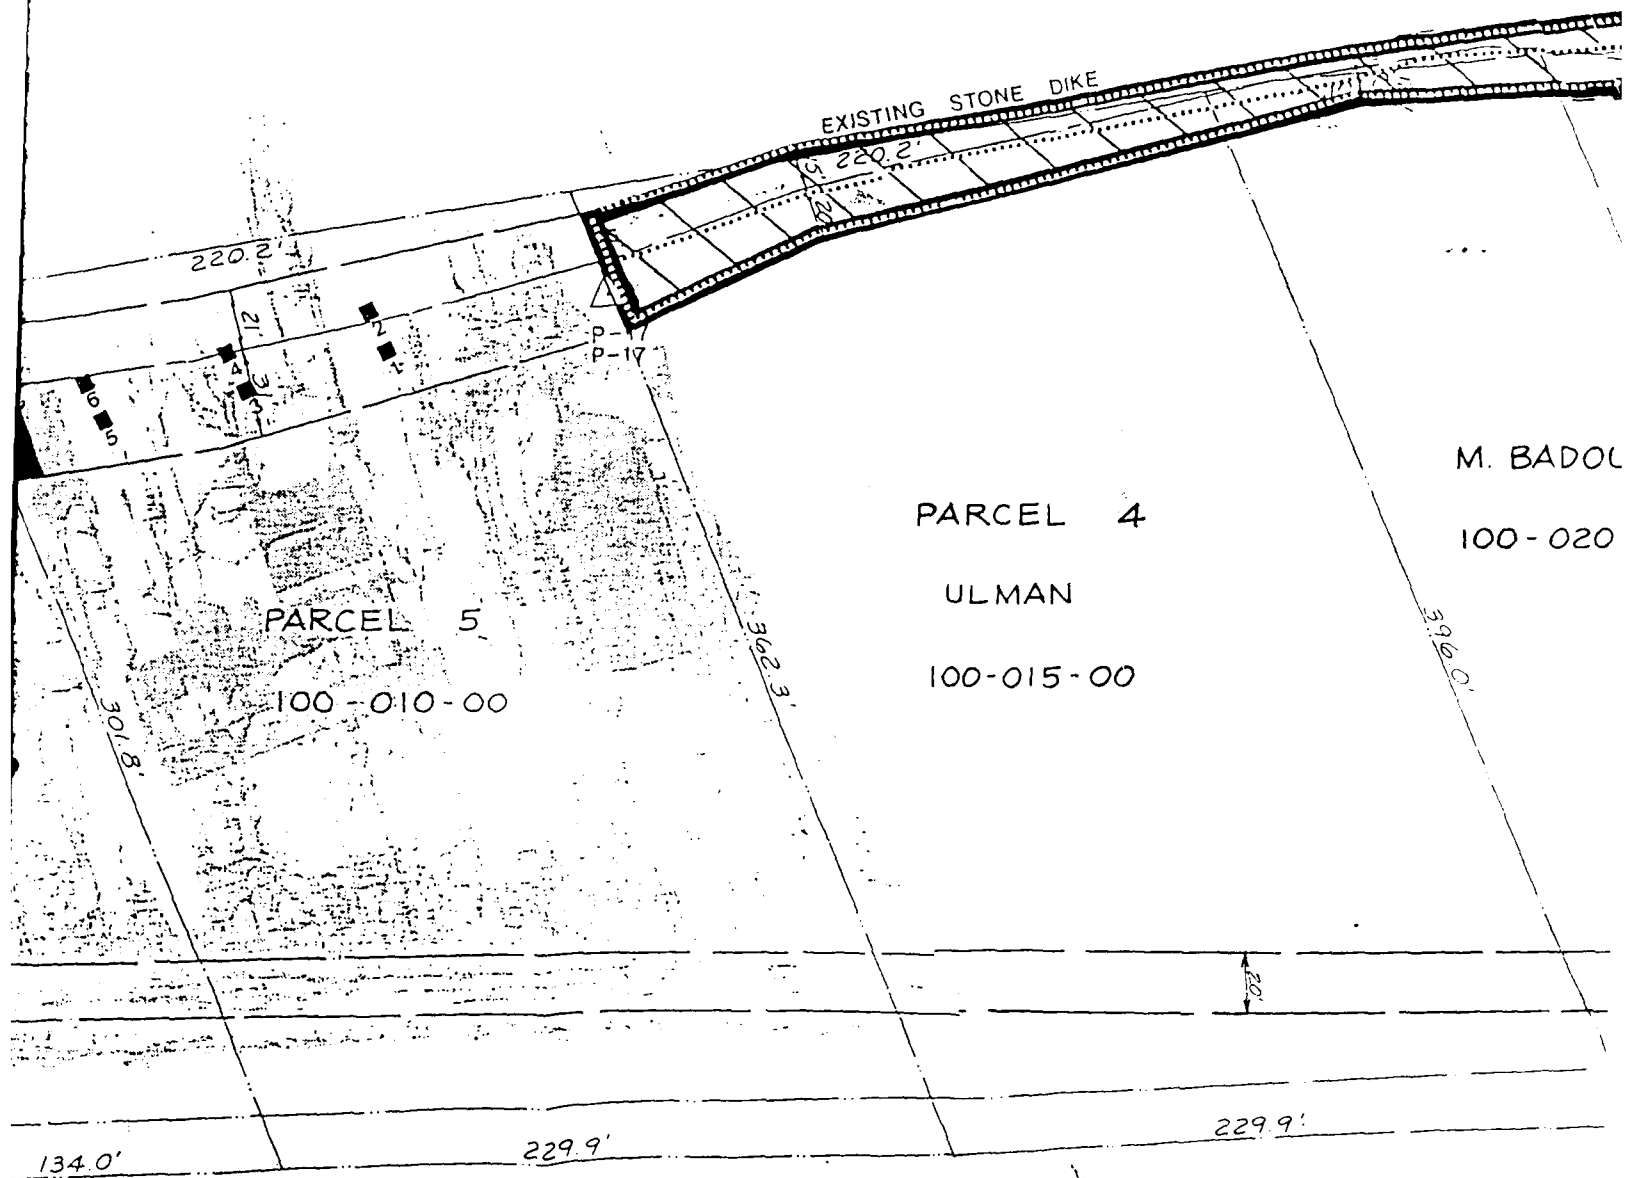
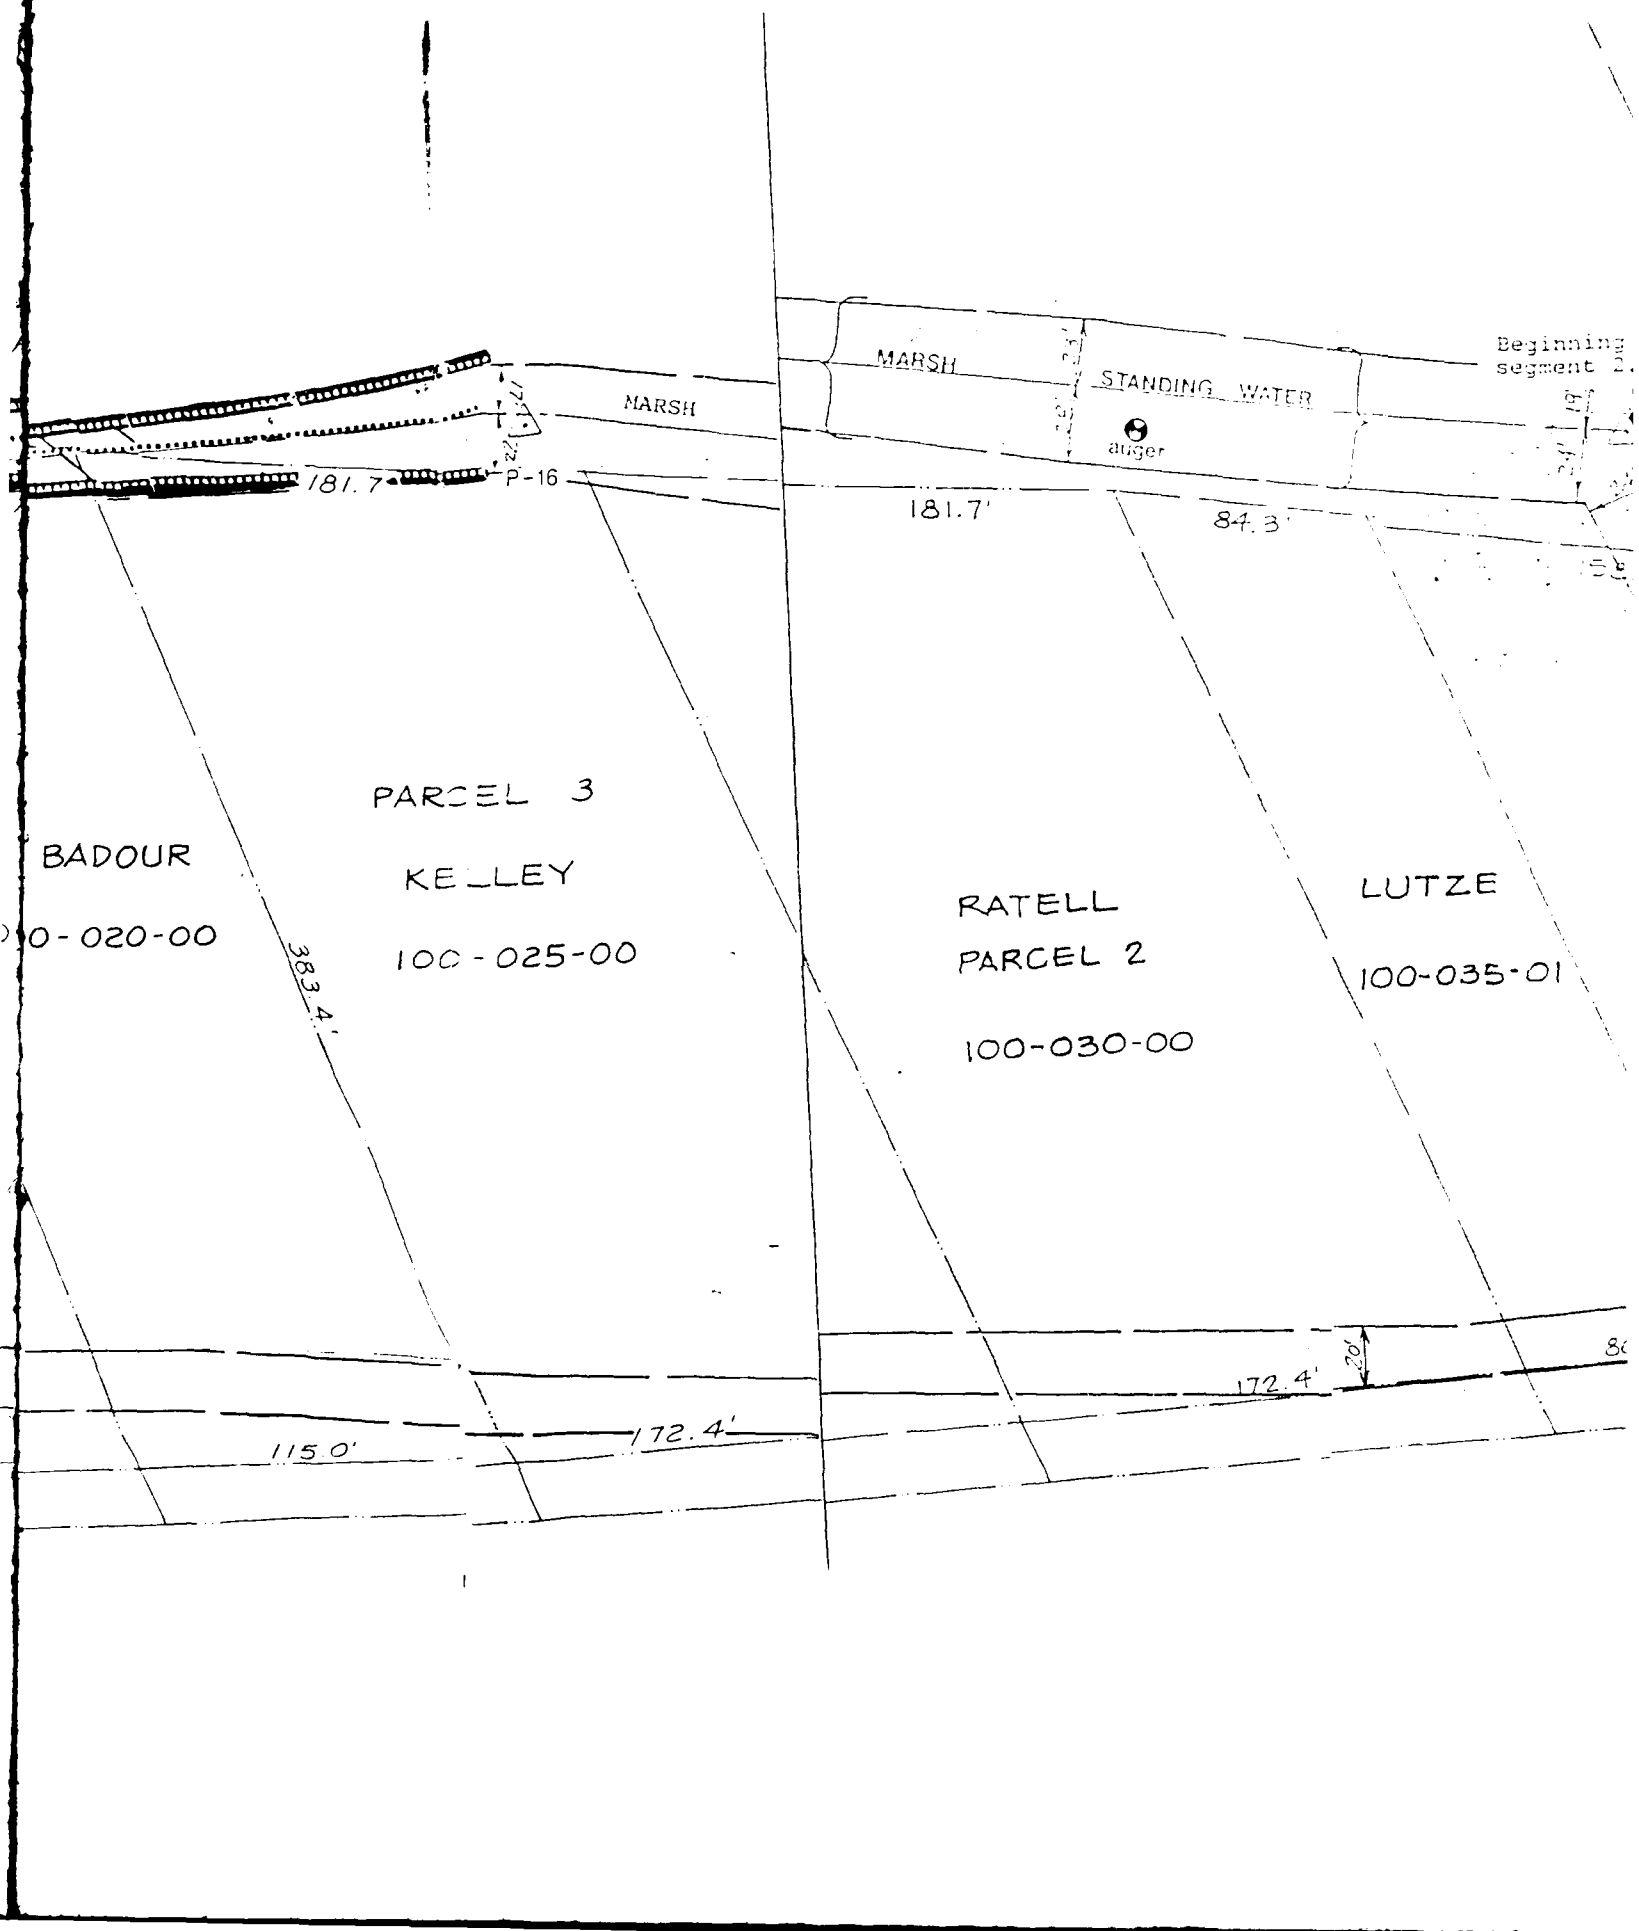
Figure 15: Machine and Shovel Transects,
Corridor Segment 2.

This transect runs eastward from P-15 to some 200 feet (60 meters) west of survey control point P-20 (Figure 15). The eastern sector from survey control point P-16 is presently a marshland covered with 1 - 2 feet of decomposed organic matter compressed to a peat like state. Standing water is present in a large part of this portion of the corridor segment as indicated on Figure 15. Soil conditions and this standing water made this portion of Corridor Segment 2 impossible for machine operation. Topsoil in this area is of recent origin and would not contain archaeological sites. One auger test was done 175 feet (24 meters) west of survey control point P-15 to test for water table.

From survey control points P-17 to P-19 this corridor segment runs directly on the beach that is covered with fallen trees and patches of scrub brush (Figure 15). This area is being actively reworked by wave action and no in-situ deposits would be found there. At survey control P-19 (Figure 15) the original corridor leaves the beach and continues to the southwest 150 feet (45 meters) and then westward paralleling the entrance road some 125 feet (38 meters). This portion of the survey corridor traversed the beach crest sector. The dune ridge and back beach are an area occupied by oak forest and small bush. A wide area of disturbance or fill was noted 98 feet (30 meters) southwest of survey control point P-19.

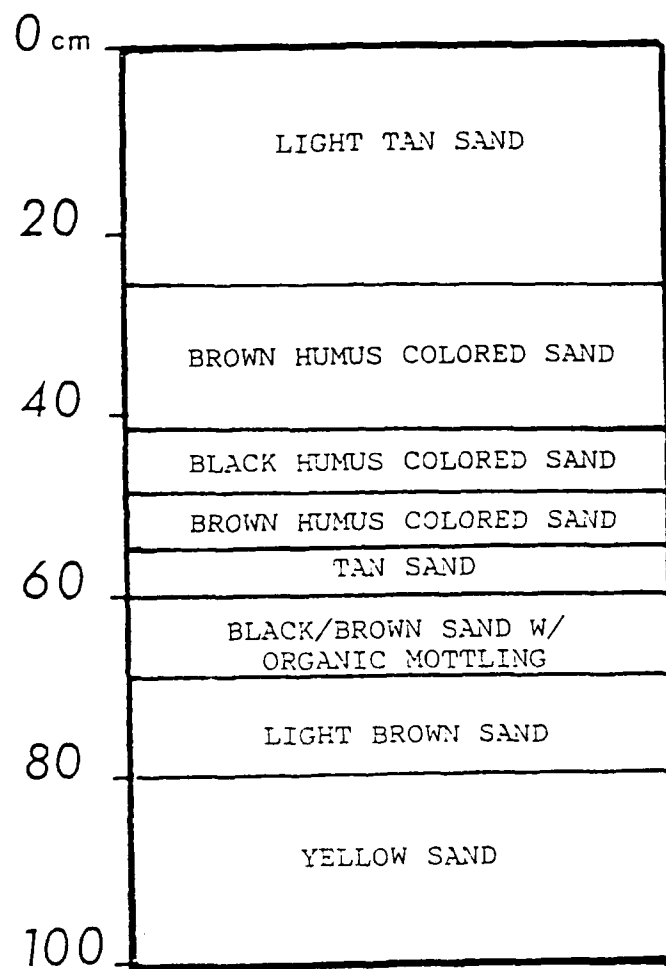
TYPICAL SOIL PROFILES

Camino's Associates CULTURAL RESOURCE MANAGEMENT Bay City, Michigan	Advance Measures Flood Control Project, Hampton Township, Bay City, Michigan.
Figure 16: Typical profile of stratigraphy at corridor segment 2.

Shovel test unit 7 was excavated just to the south of the corridor segment to determine stratigraphy at the beginning of the dune feature. A concentration of fire cracked rock was located during initial walk over of the dune area 100 feet (30 meters) southeast of this shovel test unit and outside the survey alignment. No cultural material was found associated with this material. The fire cracked rock was found in a concentration some 15 feet across. It consisted of fragments varying 2 - 4 inches in size. Shovel test unit 7, excavated to the depth of 80 cm, again showed alluvial bedding below wind deposited sands (Figure 16).

A further auger probe was done 5 feet due west of the fire cracked rock concentration to further establish the relationship between the stratigraphy there and that within the corridor segment. This auger test established that the fire cracked rock deposit lay within 20 cm of the surface (Appendix A). This might relate to the humus-colored sands found at 50 cm in depth at shovel test unit 7. Since the fire cracked rock deposit was found outside the project corridor further testing was felt unjustified. The beach deposits within the project corridor are judged to contain only redeposited cultural material, if such exists (Figure 16).

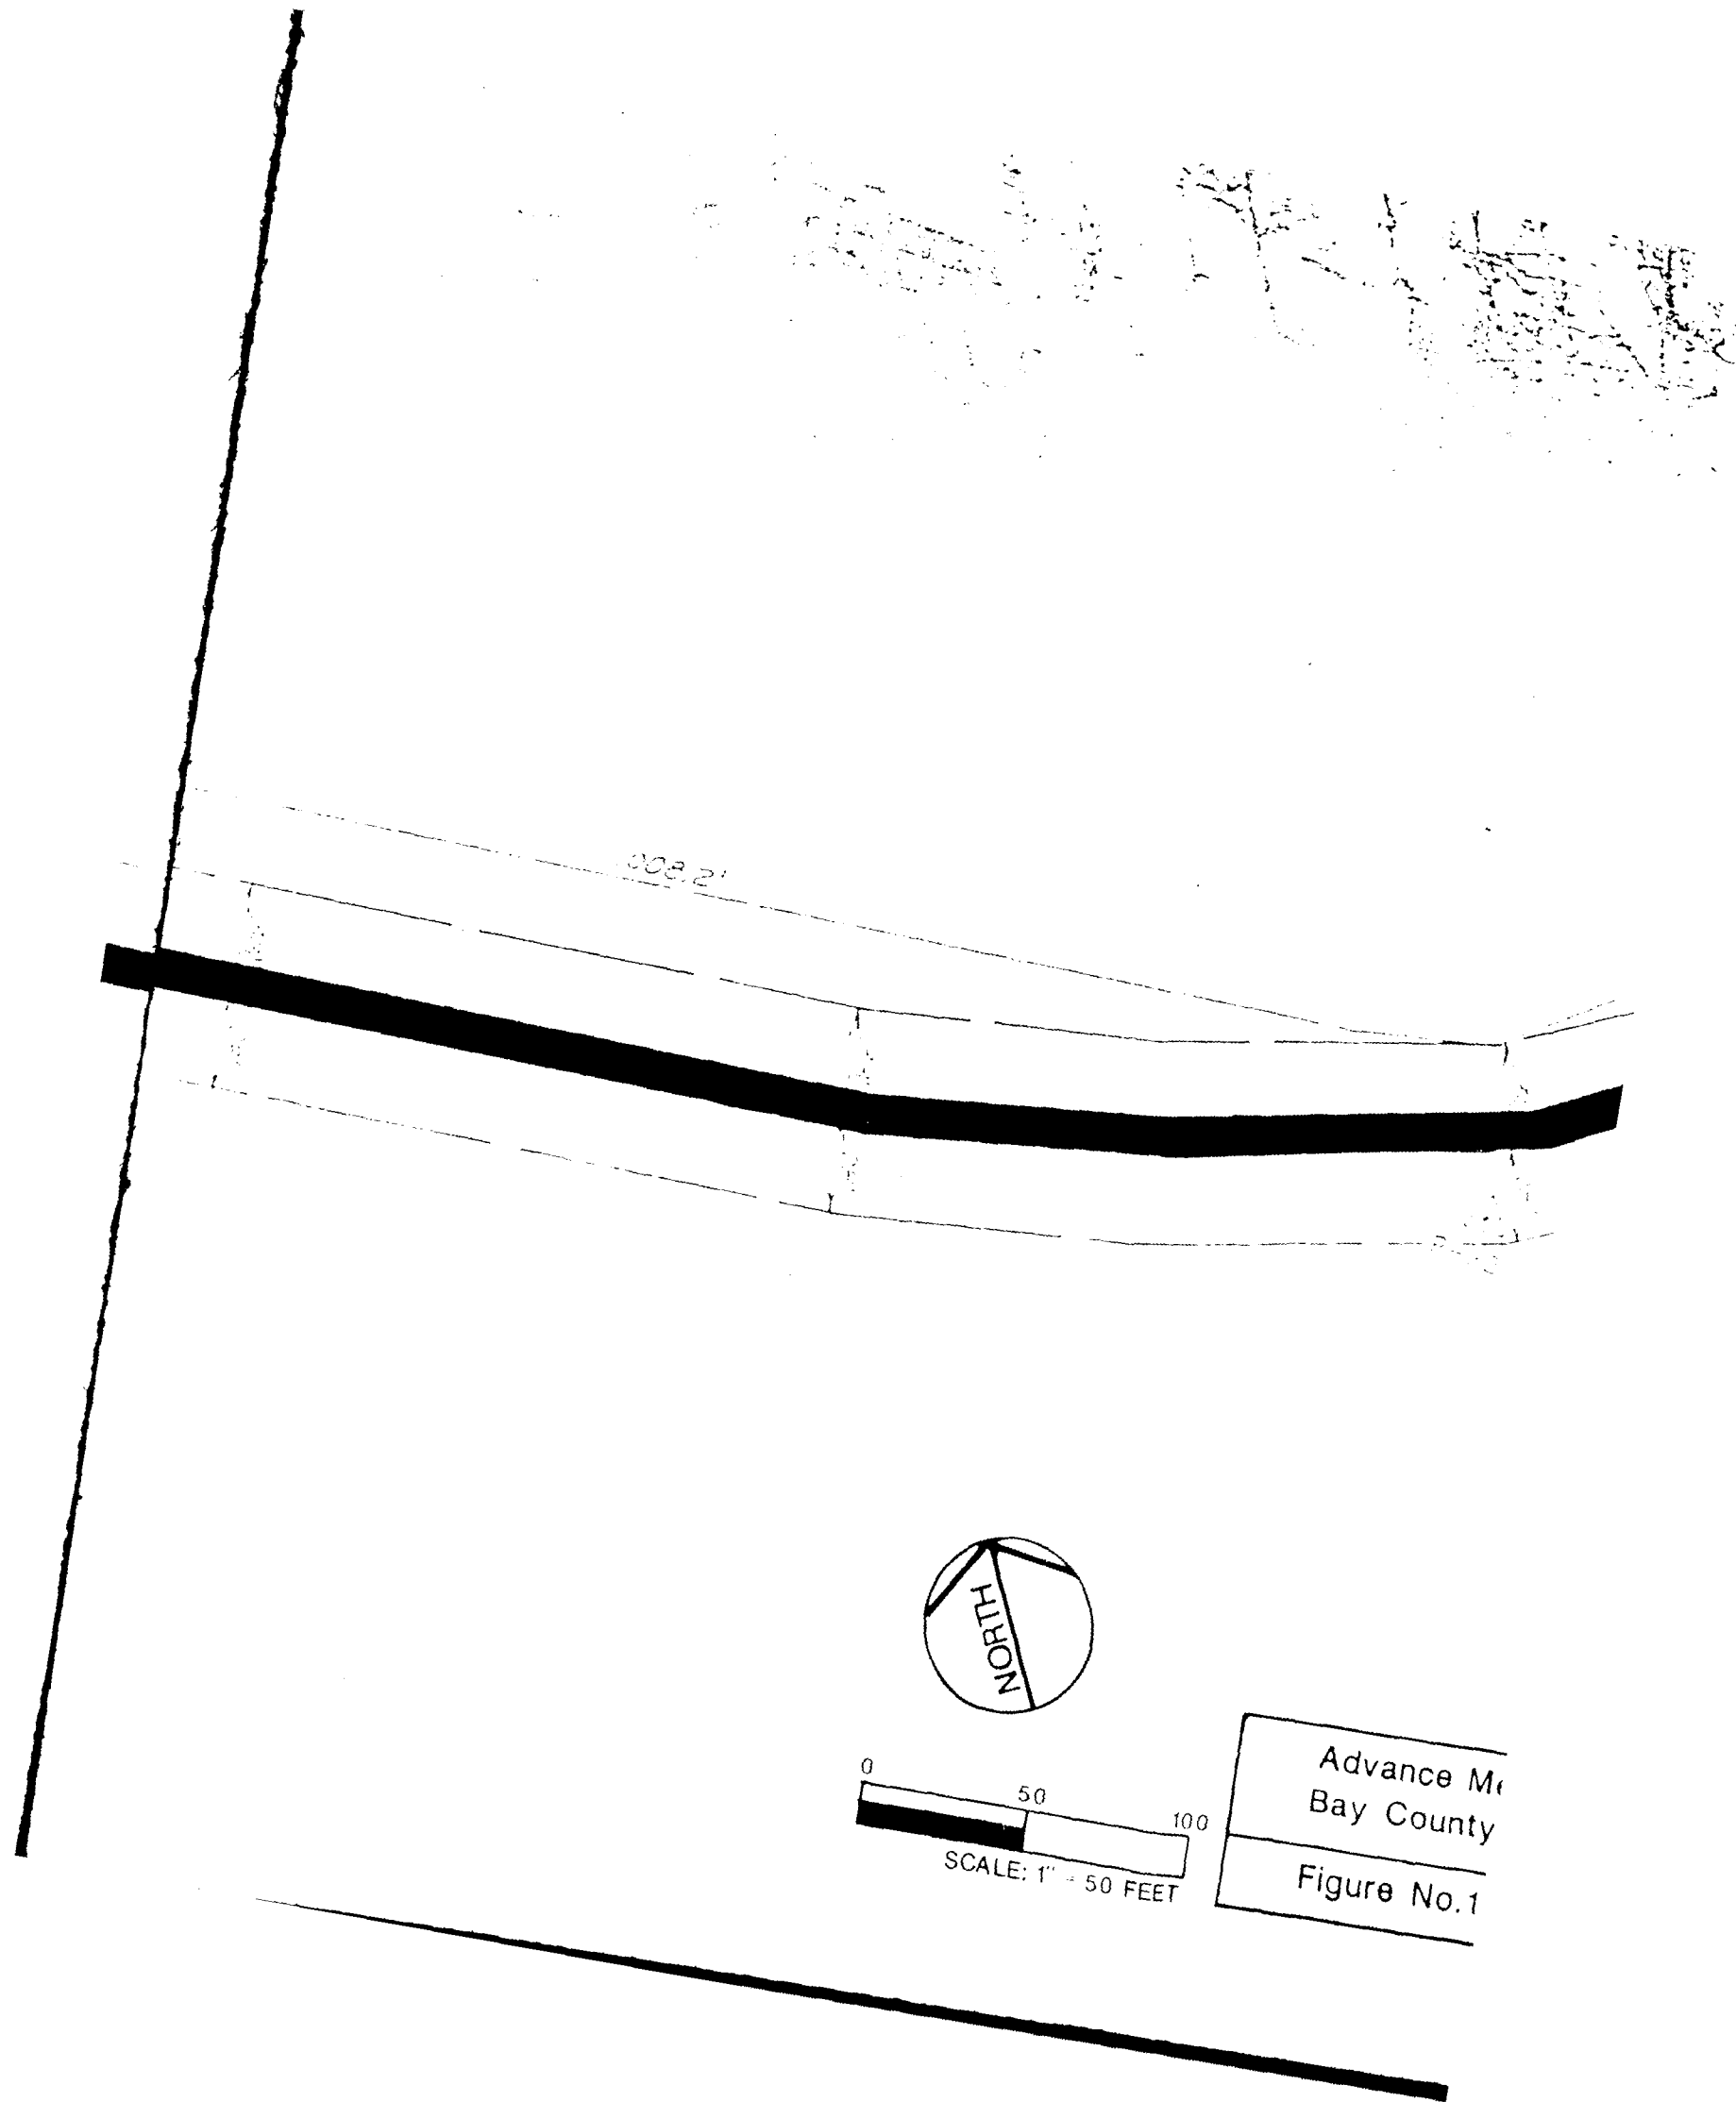
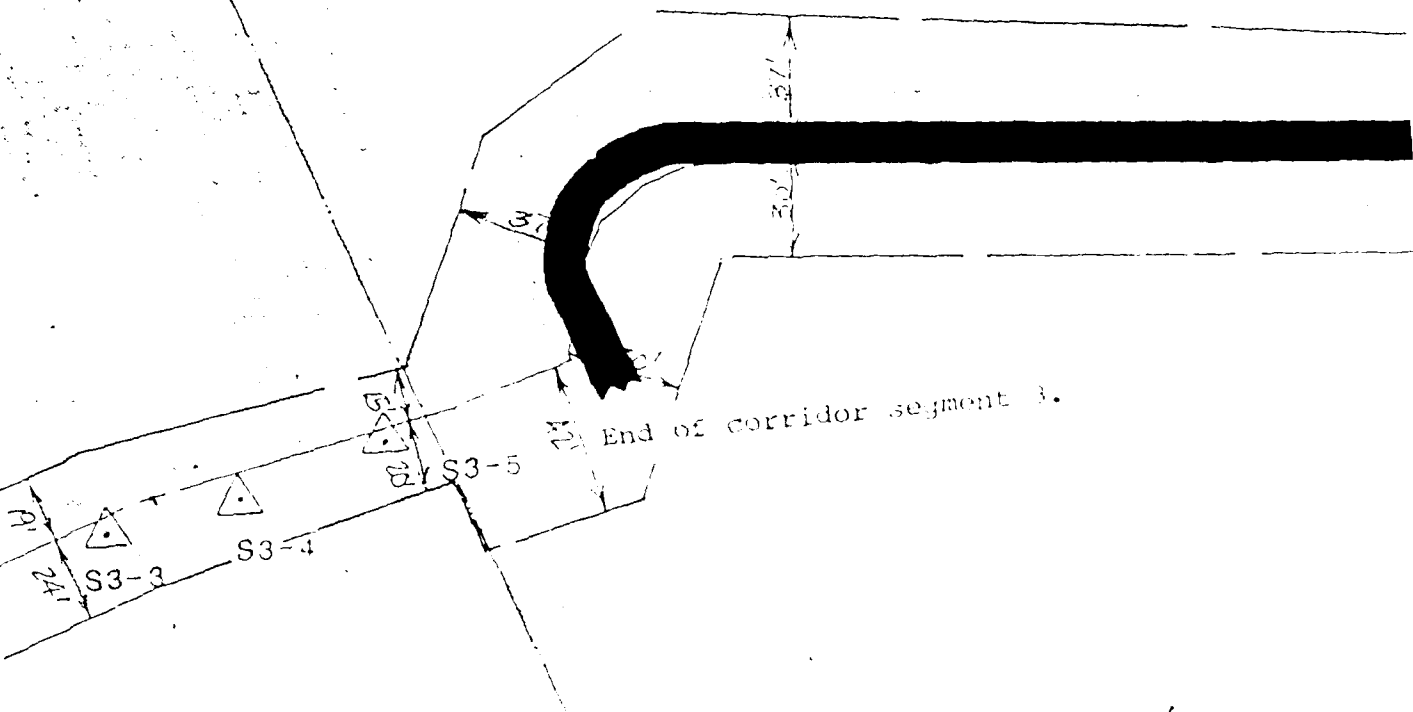
Figure 17: Machine Transect, Corridor
Segment 3.

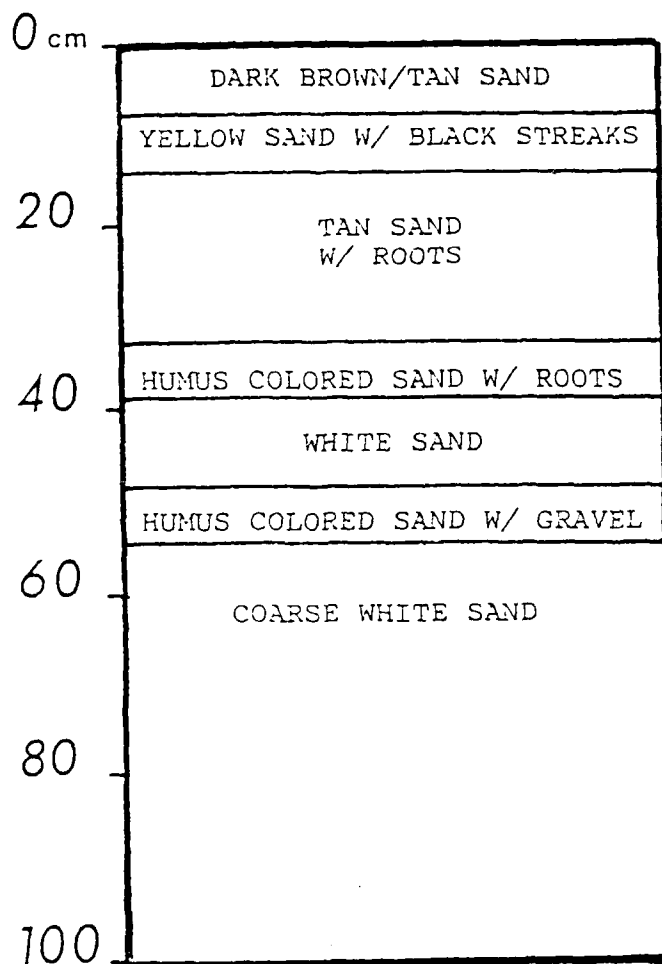
TYPICAL SOIL PROFILES

Figure 19: Typical profile of stratigraphy at corridor segment 4.

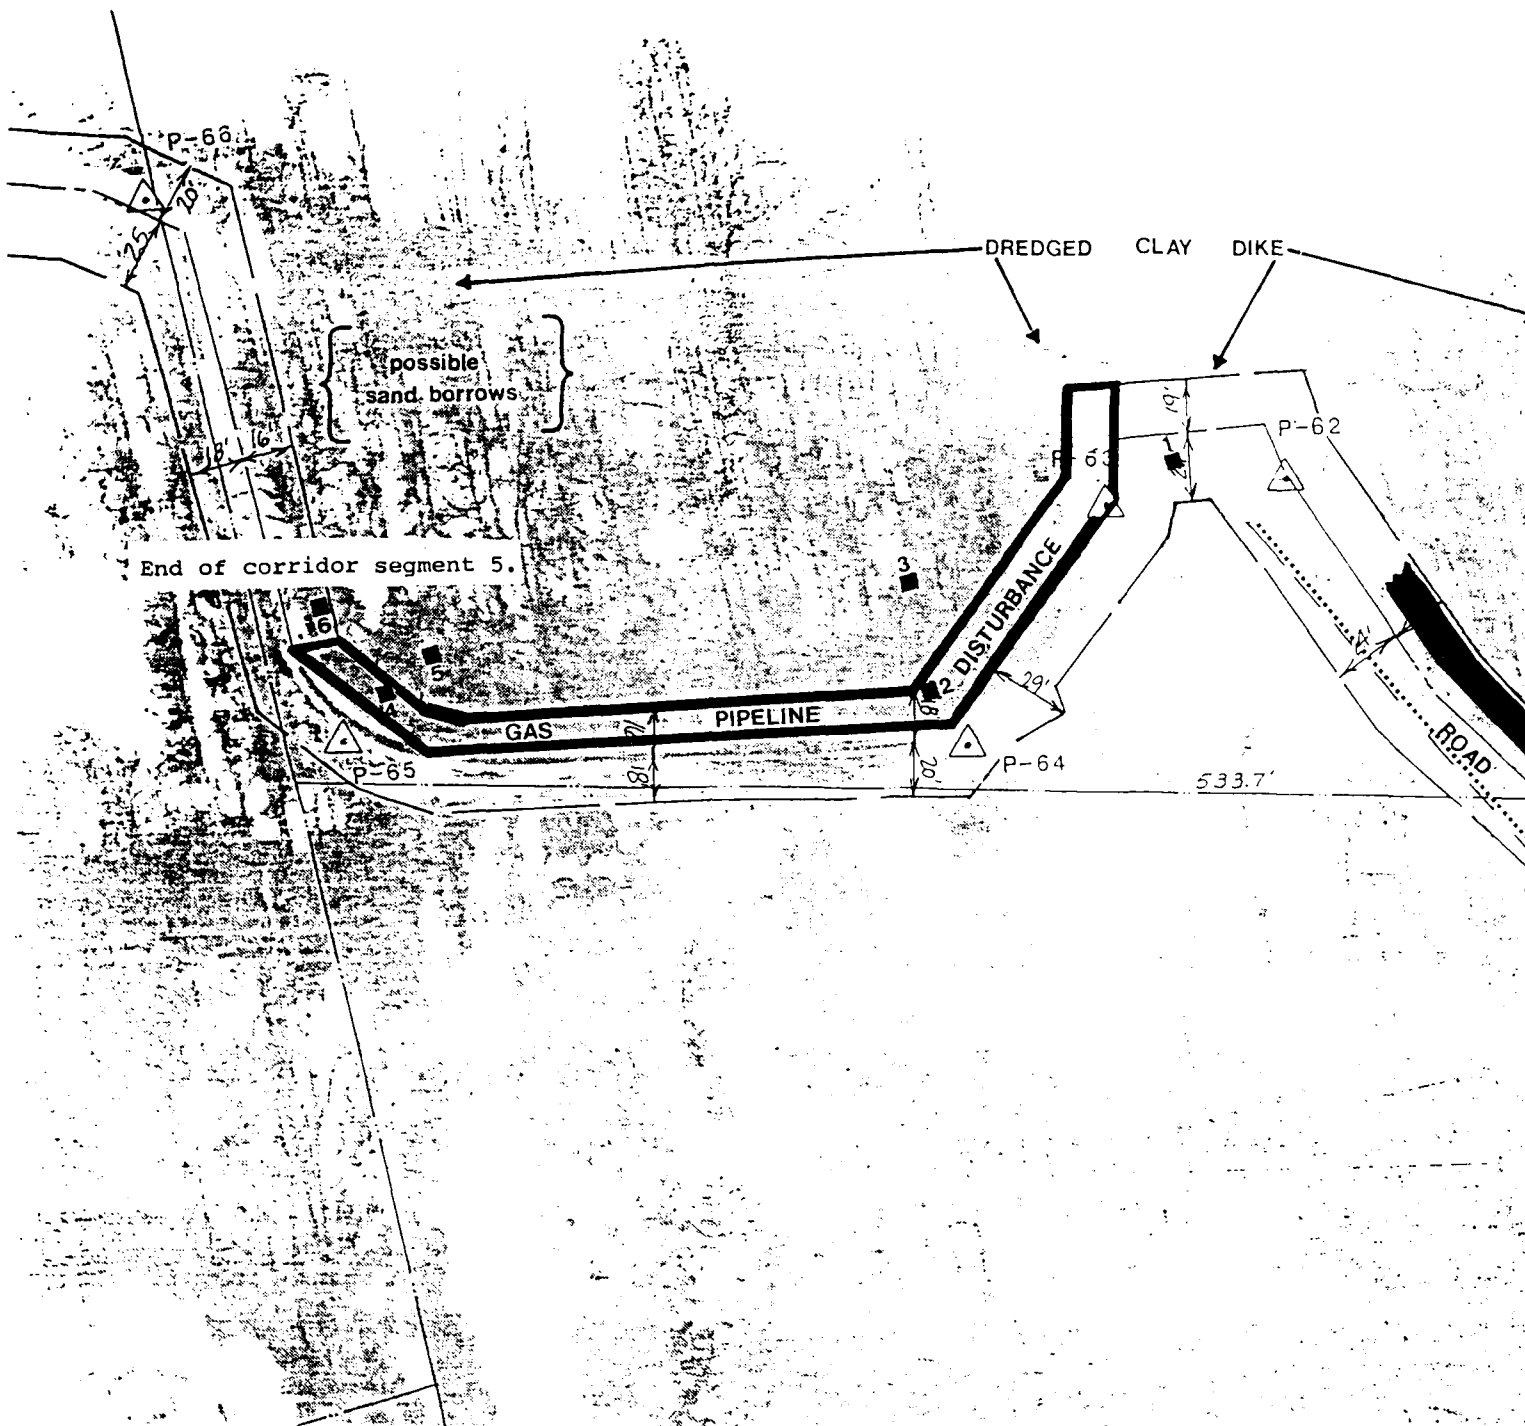
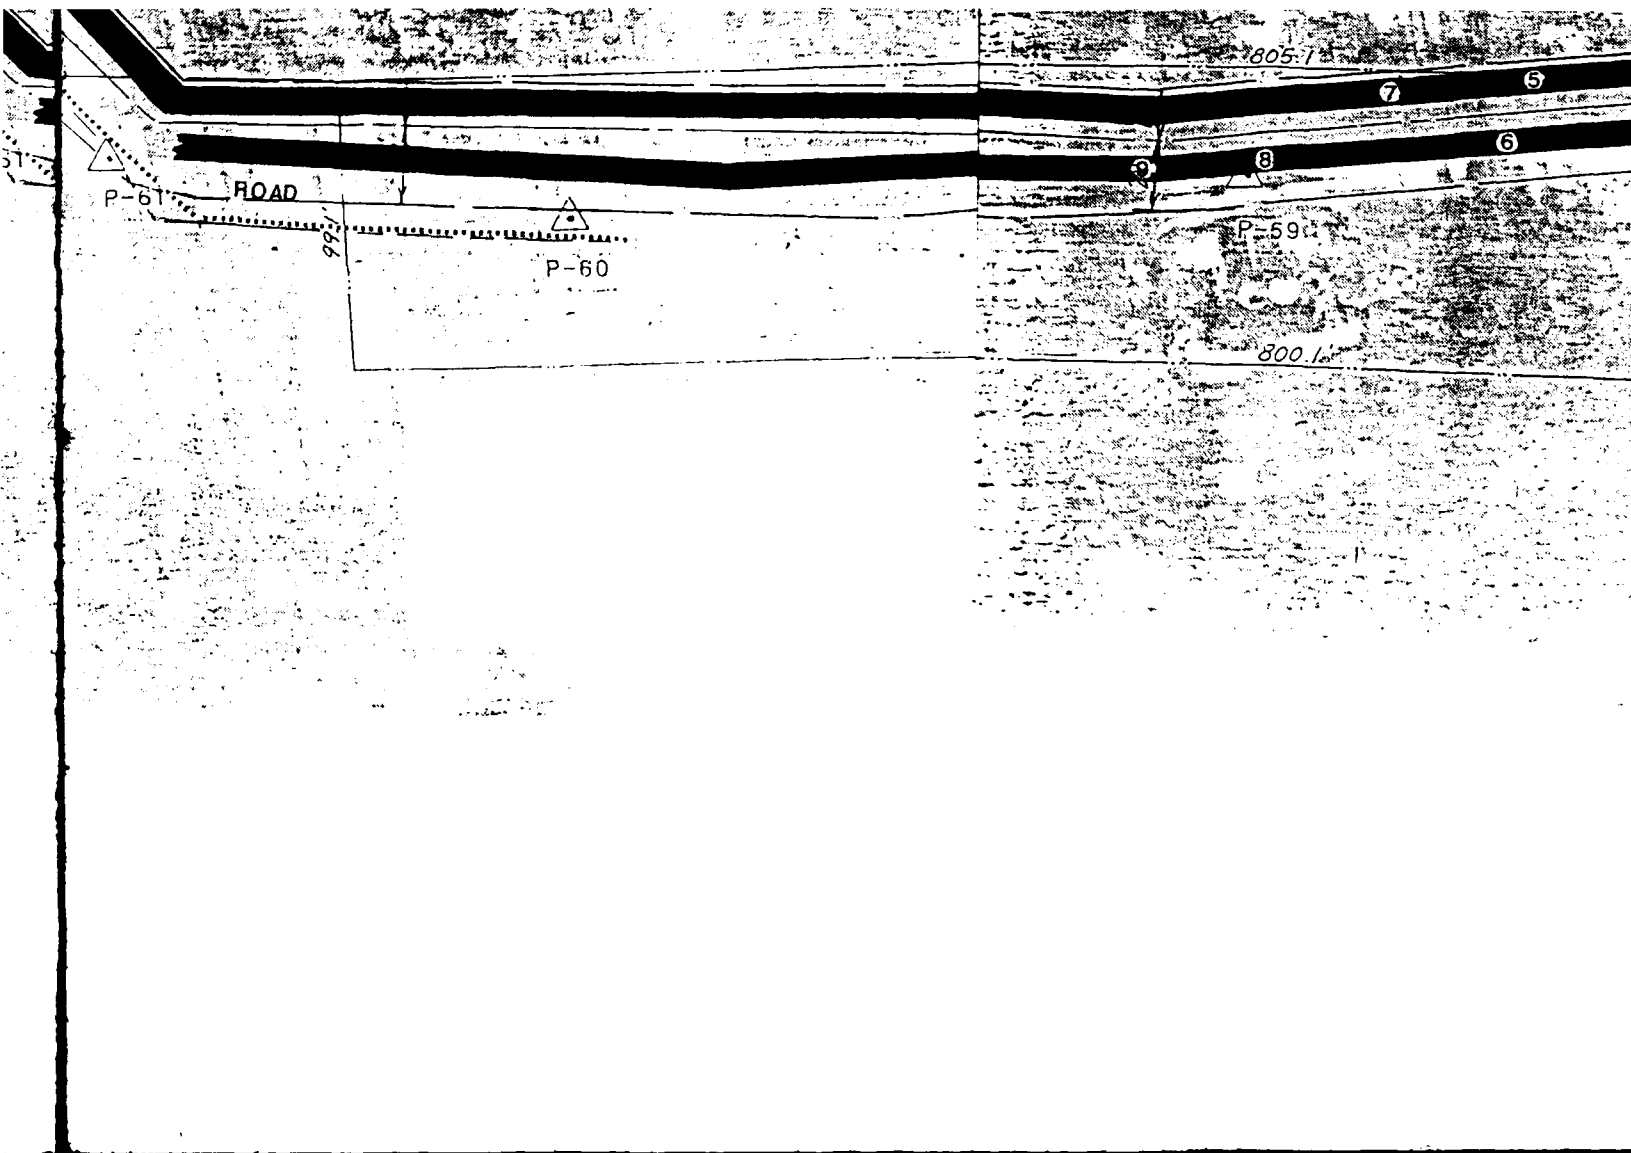
Figure 20: Machine and Shovel Test
Transects, Corridor Segment 5.

Several surface finds were noted during final survey and collection of the two machine transects in corridor segment 5, but none were of great enough significance or concentration to indicate important cultural deposits. They include a whiteware shard (late 19th century), concentrations of water-worn cobbles, historic fire pit and bottom dump, and a putative bipolar core; a flake of Bay Port chert with cortex was also found 400 feet (122 meters) east of survey control point P-57 on the service road. Table III provides a listing of cultural material found. Each item in this table is located by item number on Figure 20.

1. Large Bay Port flake (shatter) displaying part of cortex.
2. Early twentieth century impressed whiteware rimshard.
3. Historic bottle dump ca 1940's to present, included a 1/2-pint cobalt blue "Phillips Milk of Magnesia" bottle.
4. Historic midden of coal and ash.
5. Medium sized, Bay Port cortical flake.
6. A grouping of water-worn cobbles up to 4 inches in diameter in association with a medium piece of broken Bay Port chert with cortex and a putative bipolar core of exotic chert.
7. Twentieth century leather shoe.
8. A large grouping of water worn cobbles up to 5 inches in diameter with several pieces of broken glacial chert.
9. A large grouping of water worn cobbles 4 inches to 6 inches in diameter.
